Intended for  
**Anderson Bell + Christie Architects**

Project no.  
**30804**

Date  
**19<sup>th</sup> March 2013**

# **BARRHILL MEMORIAL HALL M&E CONDITION SURVEY REPORT**

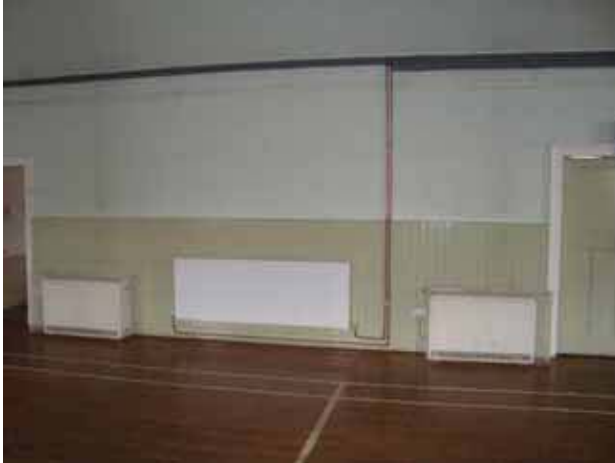
Main Hall indicating electric storage heaters & LTHW radiator.

The electric storage convector heaters are of indeterminate age but are much older. This system is beyond its economic life and the retention of this system should not be considered.

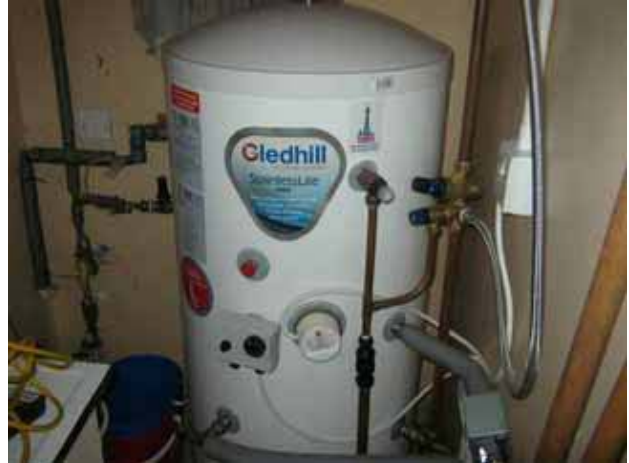
Mains pressure hot water cylinder.

The mains pressure hot water cylinder is in good condition along with the primary LTHW heating system and back up electric immersion heater, this installation having been installed circa 2011. The cylinder is located within the store adjacent to the kitchen.

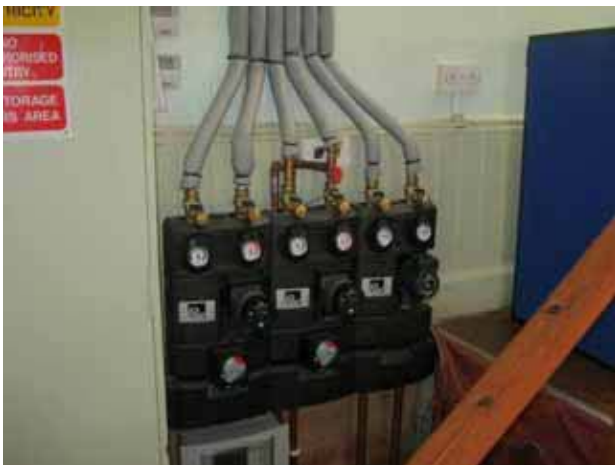
LTHW manifold fed by biomass boiler.

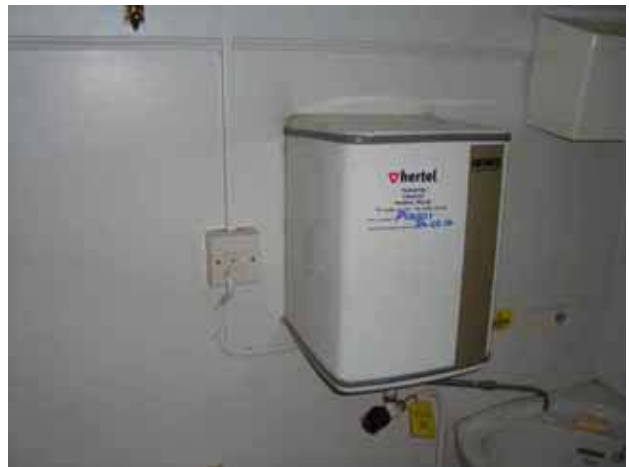
Point of use electric water heater.

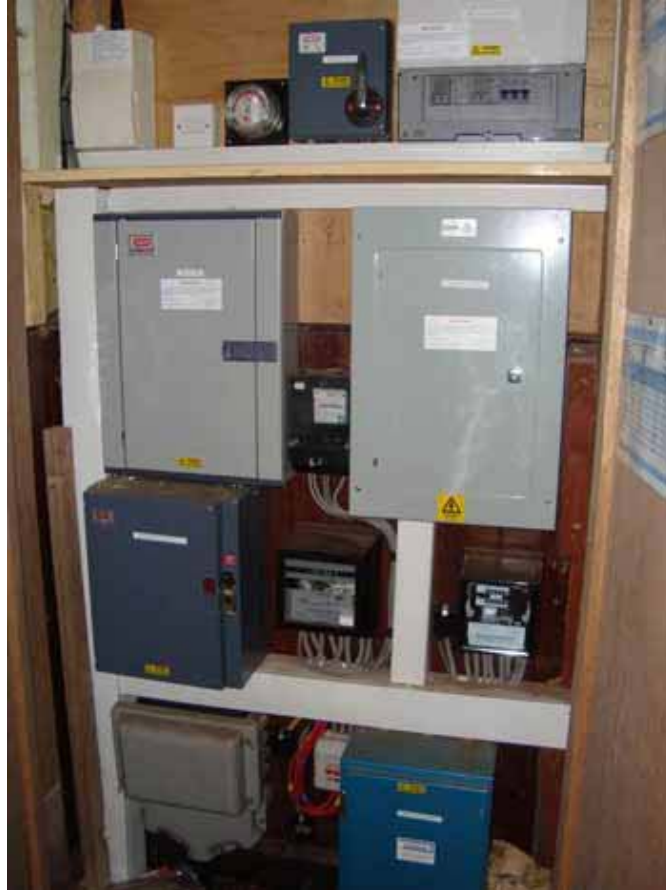
Electrical incoming cable head meters & distribution boards

The incoming electrical supply and cable head is in the ownership of the electrical supply authority and as such any future maintenance or replacement shall be their responsibility. It should be noted that there are two electrical meters presently installed one general tariff and one on an off-peak tariff serving the existing electrical storage heaters. We would recommend the isolation and removal of the off-peak tariff meter as there shall be on going charges with this meter even though the storage heaters are not used and no electricity consumption through this meter.

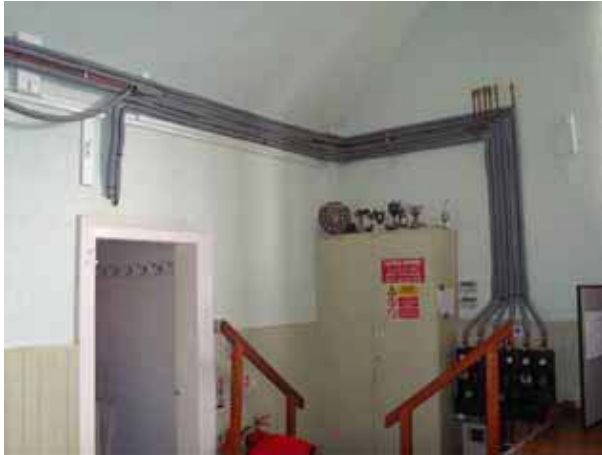
LTHW pipework indicating missing thermal insulation.

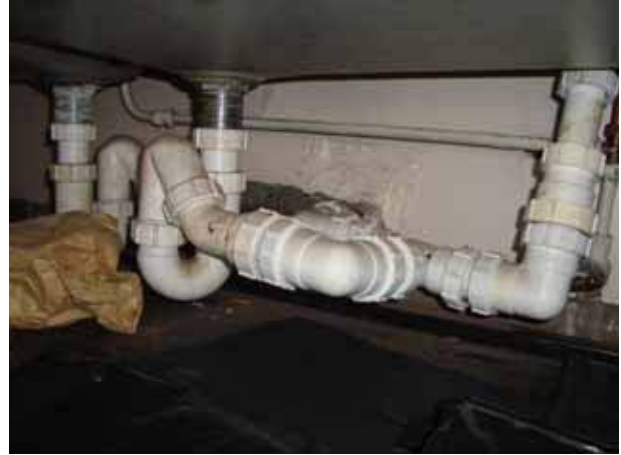
The above slab drainage system whilst it appears still operational, is a mismatch of various pipe materials with a number of add-on's and extensions.

PVC drainage pipework below kitchen sinks.

Without the benefit of internal CCTV surveys the condition particularly of the cast iron pipework cannot be confirmed. We would recommend that further CCTV surveys be undertaken to confirm the condition and suitability for future use or alteration.

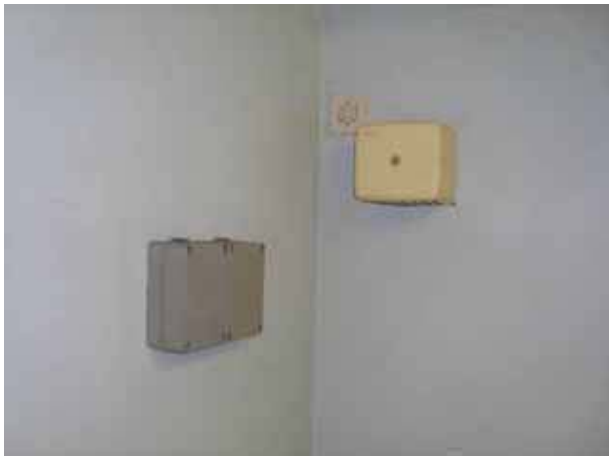
Those wall mounted extract fans which have been installed are generally inoperable at present. They are beyond their economic life and the retention of these systems should not be considered.

Existing wall mounted extract fan.

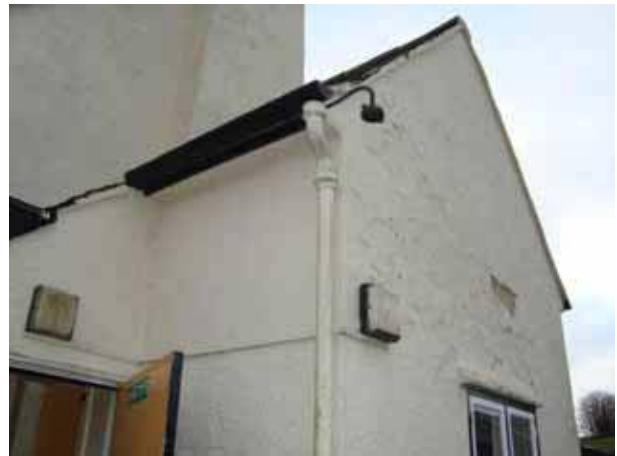
The existing lighting installations are generally old and do not meet current Building Regulation standards. There are existing redundant external fittings which should be checked to ensure they have been isolated, disconnected and left in a safe condition.

External lighting plus redundant fitting.
