## STRUCTURAL SURVEY REPORT

### BARRHILL MEMORIAL HALL, MAIN STREET, BARRHILL

Project ID: J2742

Dated: March 2013

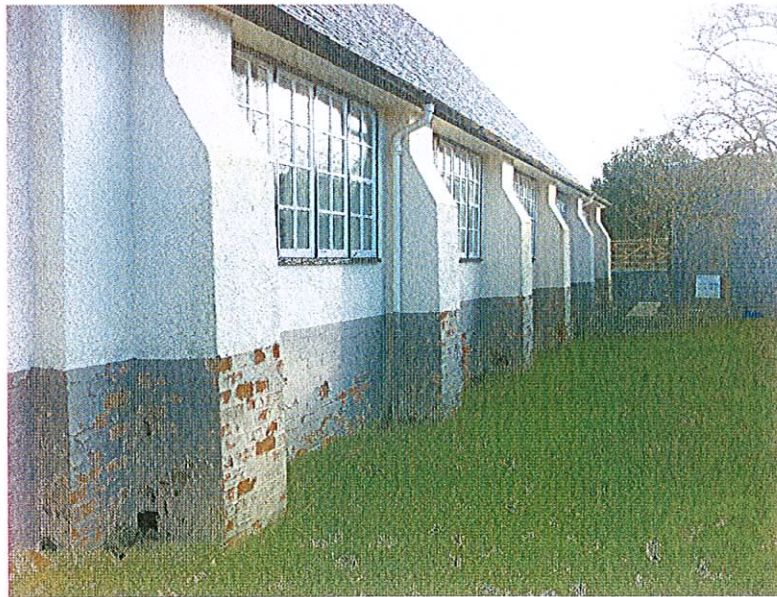
Photo 02

- 3.1 The building generally comprises a single storey main hall with two rooms and toilets to the front elevation and a kitchen and a WC on the right hand gable.
- 3.2 The rooms to the front have slated T-Junction roofs with the main hall, leading to the formation of valley gutters. The WC to the side has a duo pitched roof and the kitchen generally a mono pitched roof. ( Photo 1)
- 3.3 The external walls are of masonry construction, no opening up was undertaken to confirm if this is of cavity construction. The lower 1.0metres of the wall consists of a painted brickwork finish. The areas of wall above this are render finish.
- 3.4 The walls to the rear have brick buttresses, most likely to support the thrust from the raised tie roof trusses. (Photo 2)
- 3.5 The internal walls are generally of masonry construction which is hard plastered.

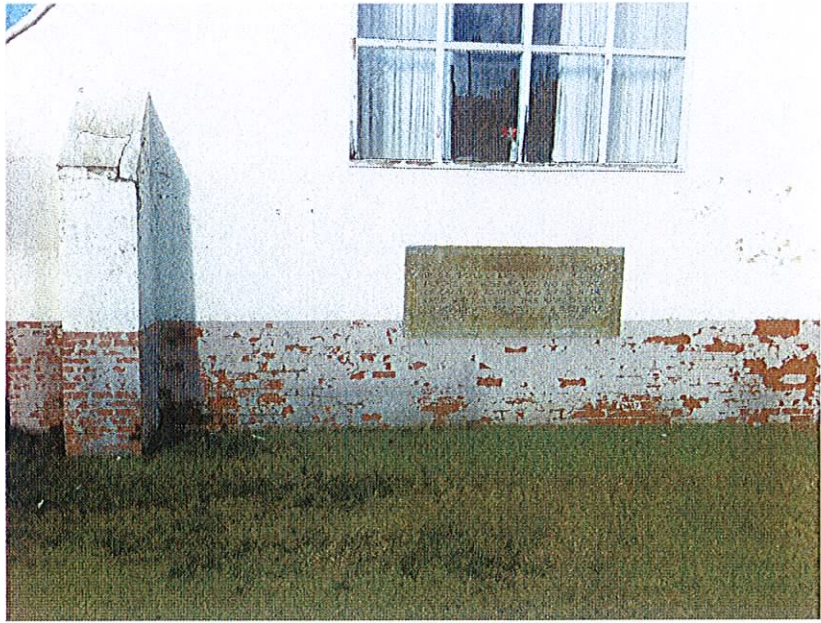
Photo 03

- 4.0 The external inspection of the walls and roofs of the properties was conducted from ground level.
- 4.1 Some cracking of the render was evident in areas; however this is not expected to be due to structural failure of the underlying masonry. Spalling of the painted brickwork especially on the rear and gable elevations was recorded. (Photo 3)

- 7.1 The building generally is in reasonable condition for its age and form of construction
- 7.2 We would recommend that the areas of spalled brickwork are repaired.
- 7.4 It would be prudent to install some form of cut-off drain to the rear of the property as this run-off is likely to contribute to the spalling of brickwork due to the absorption of moisture.
- 7.5 Rot and asbestos surveys should be obtained for the property.
- 7.6 An inspection should be made of the roof space when sufficient access is available

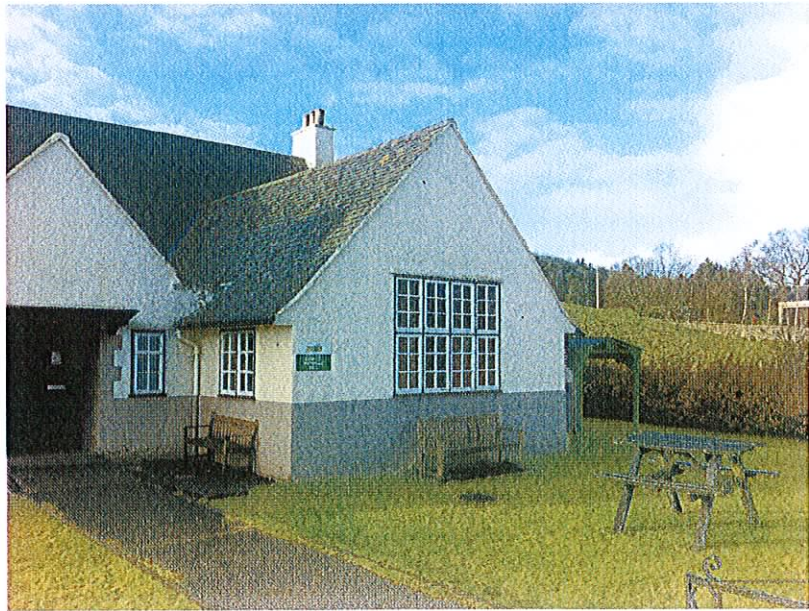
Photo 4

- 4.4 Areas of damp were noted in some areas at the valley gutters, this is possibly caused by a blockage in the outlet. (Photo 4)
- 4.5 From our inspection we are of the opinion that the small corridor on the gable and the area of the kitchen at the rear corner have been added since the original construction of the building
