REFURBISHMENT/DEMOLITION ASBESTOS SURVEY REPORT

BARRHILL COMMUNITY CENTRE, MAIN STREET, BARRHILL.

A/0216

26TH MARCH 2013

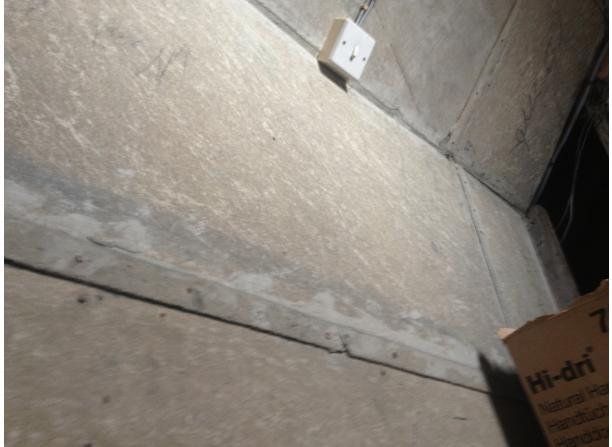
06480 KITCHEN ATTIC WALLS – CEMENT SHEET

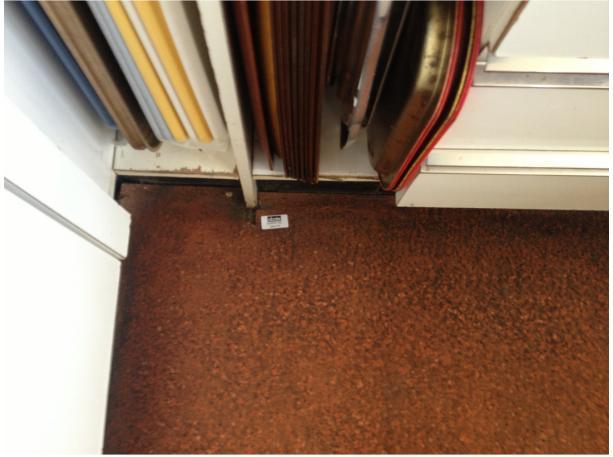
06481 KITCHEN – ORANGE LINO
